**DAM SAFETY SECTION
CRITICAL INFRASTRUCTURE DIVISION**

Downstream Hazard Assessment

DAM: Lake Deerwood Dam

INSPECTION DATE: May 22, 2012

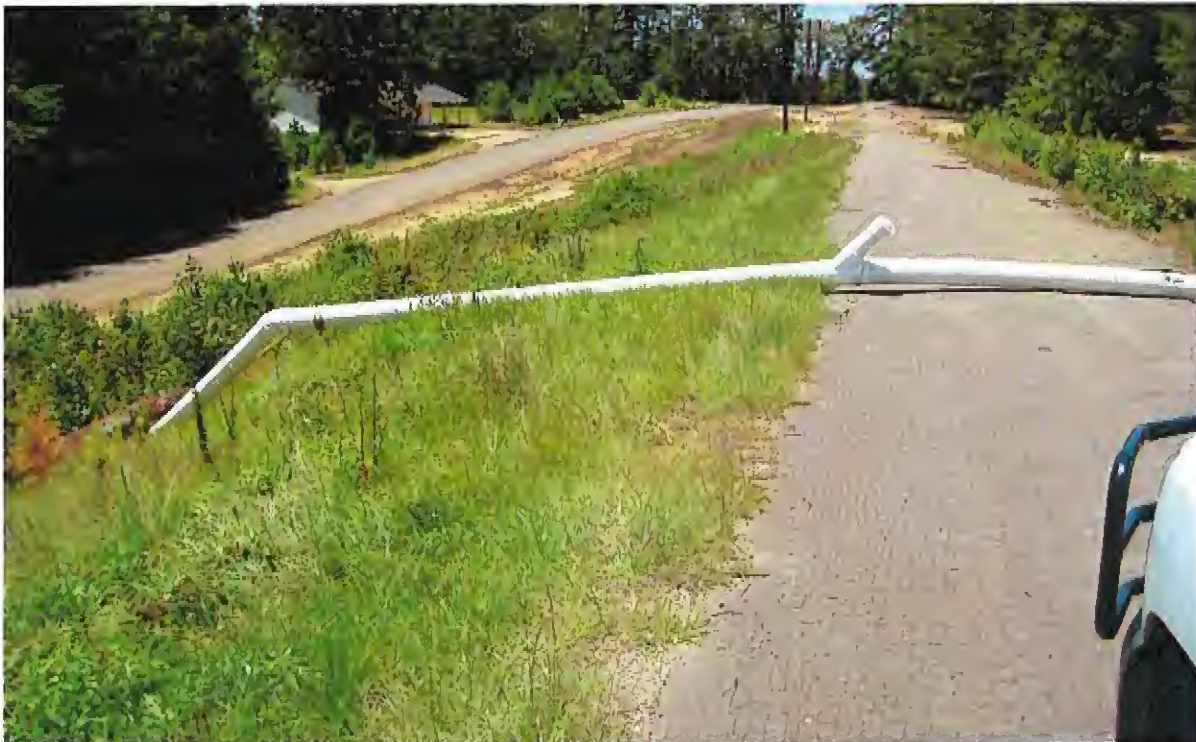
- An 8-inch PVC siphon was installed over the embankment to maintain the water level below the level of the damaged principal spillway inlet [Photos 1-3],

Photo 1: View of the 8-inch PVC siphon that was installed to lower the lake level.

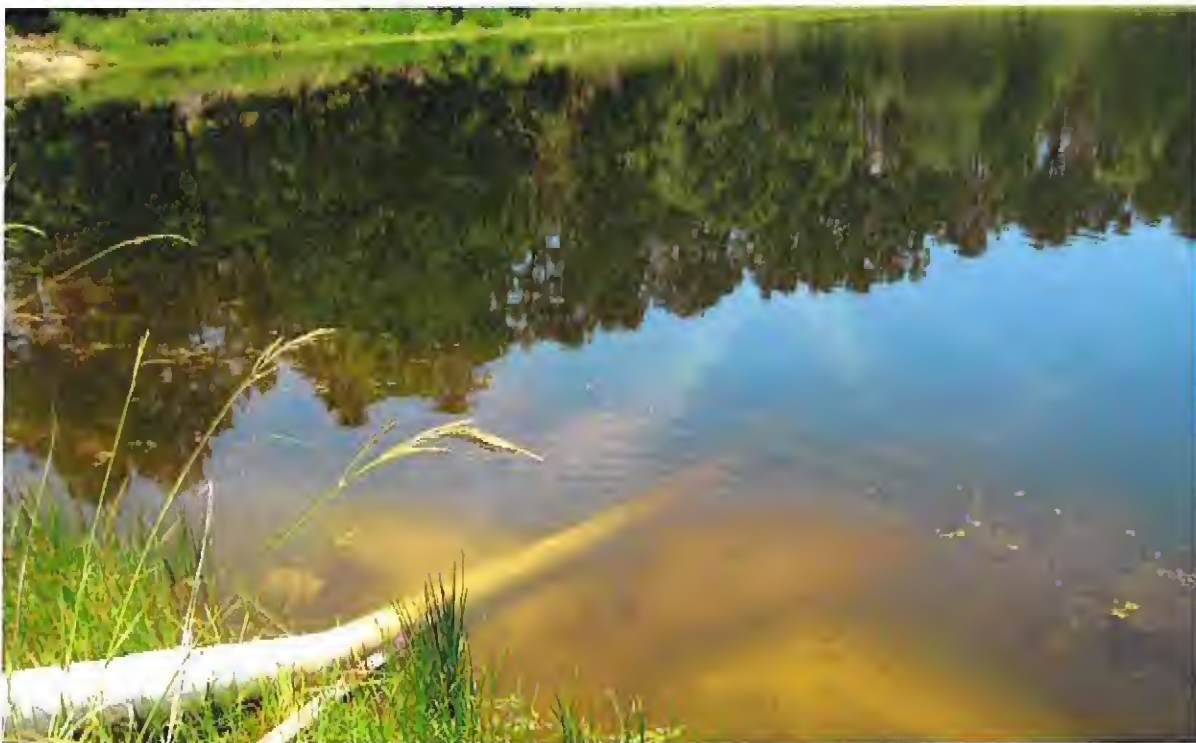
Photo 2: Upstream end of the siphon.

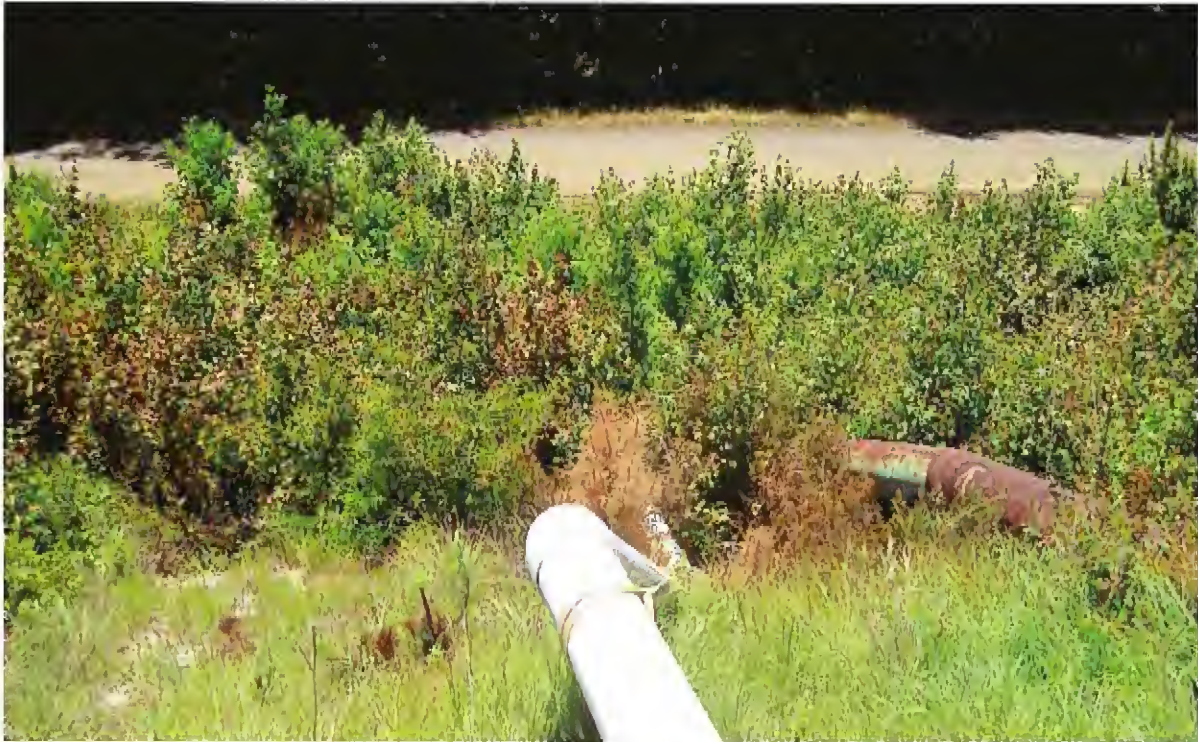
The March 16, 2010 inspection found Lake Deerwood Dam to be in poor condition due primarily to the failed condition of the principal spillway. The invert of the steel pipe was badly deteriorated and had rusted out, allowing water to flow uncontrolled down the downstream slope. Erosion of the slope in the vicinity of the principal spillway was extensive and appeared to have been occurring for some time.

Photo 3: Downstream end of the siphon. Note the existing deteriorated principal spillway pipe in the right of the photo.

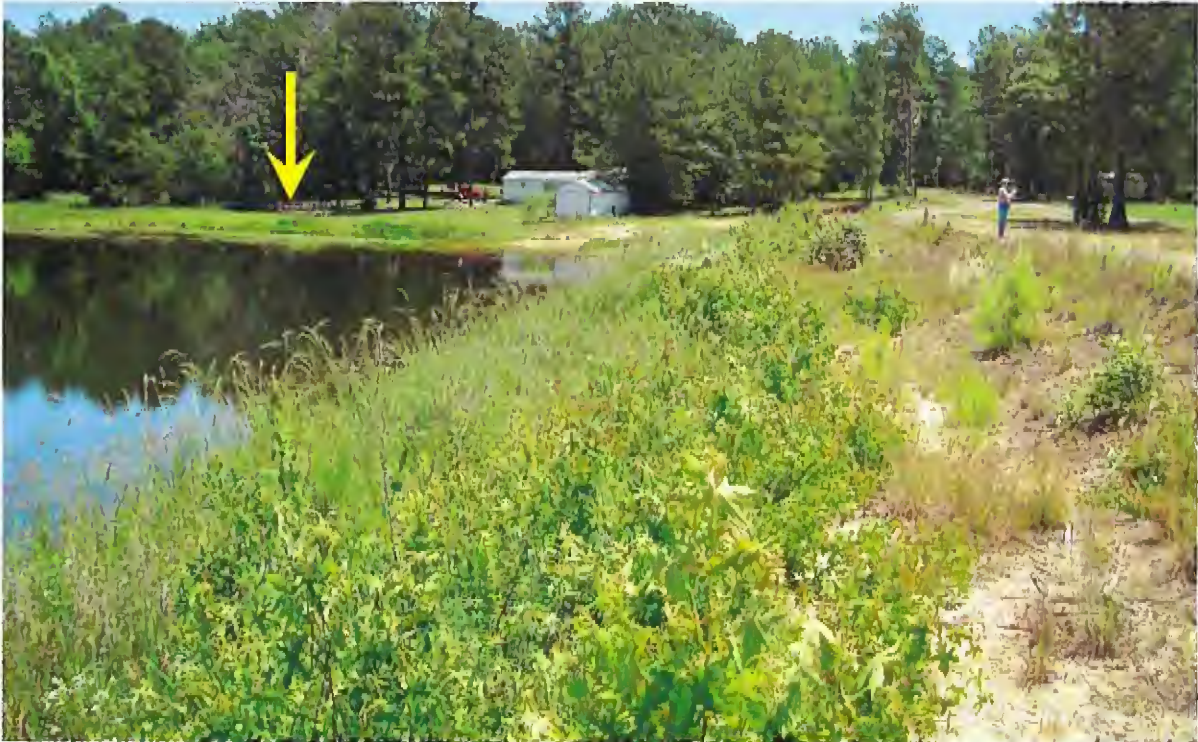
- The water level was measured with a hand level to be 3.6 feet below the crest of the principal spillway and 8.7 feet below the top of dam [Photo 4],
- Standing seepage was observed on the toe of the dam near the principal spillway [Photo 5],

Photo 4: View of the upstream slope and reservoir pool. Note the dock in the background is significantly higher than the water surface.

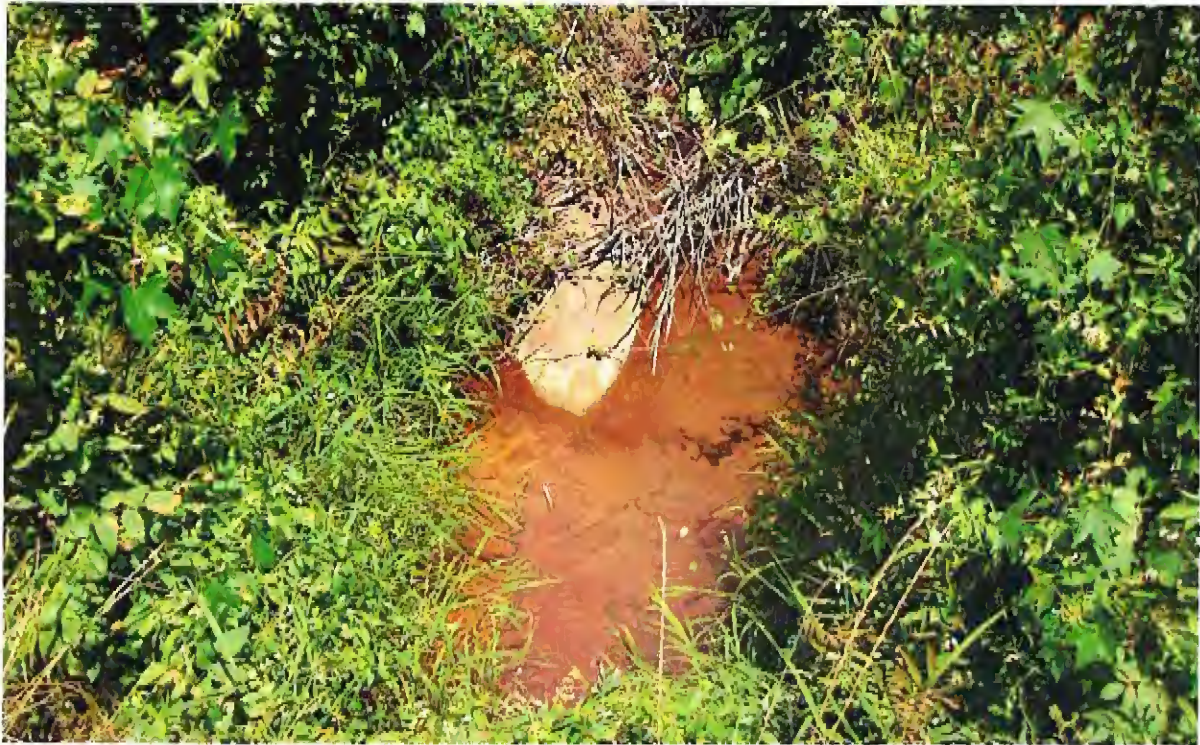
Photo 5: Standing seepage observed at the toe of the dam at the principal spillway pipe outlet.

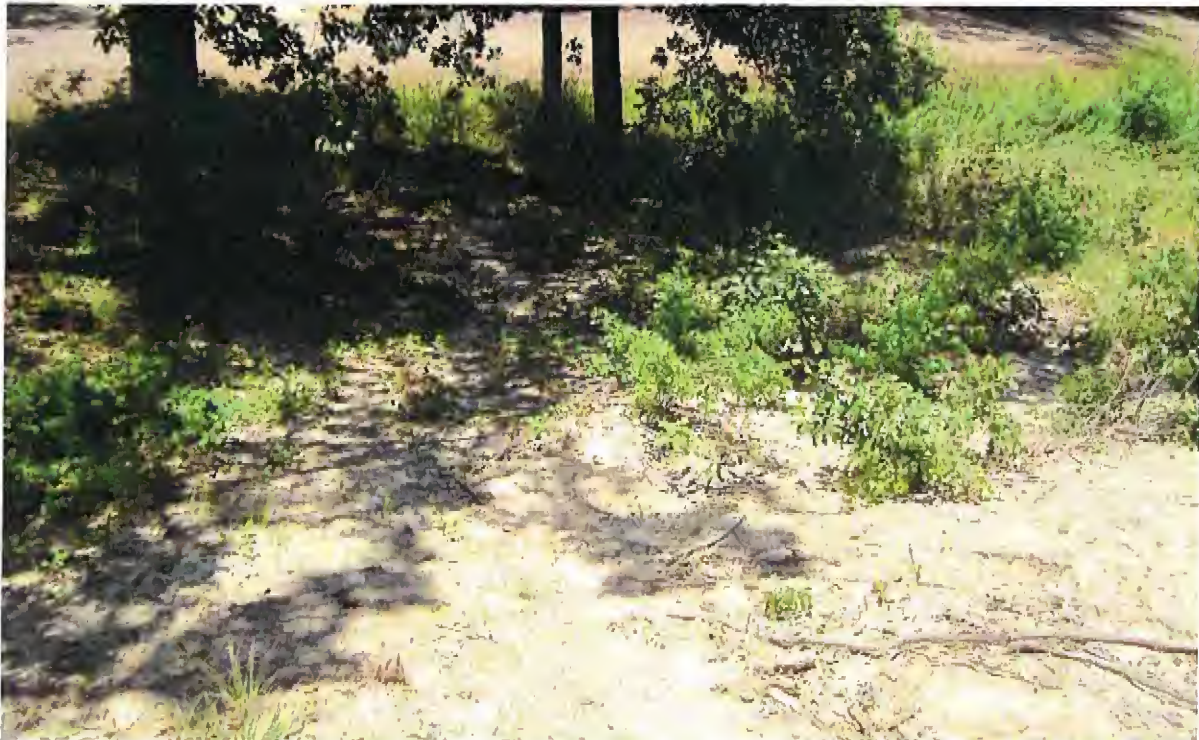
- The high phreatic surface on the downstream slope that was observed in the March 2010 inspection (when the principal spillway was engaged) was not observed during the current inspection [Photo 6],

Mr. Rivers relayed the Association's efforts to salvage and repair the dam given the limited funds available to the Association. He also stated that upon lowering of the water level, an abandoned beaver den was discovered on the upstream slope on the left end of the embankment, in the vicinity of where the high phreatic surface was observed during the March 2010 inspection. Mr. Rivers reported that the beaver den had been repaired by collapsing the burrow and compacting it with clay material.

Photo 6: Area of the downstream slope that was moist from seepage in the March 2010 inspection. The slope was dry during the current inspection. Mr. Rivers reported that a beaver burrow had been repaired on the upstream slope opposite this area.

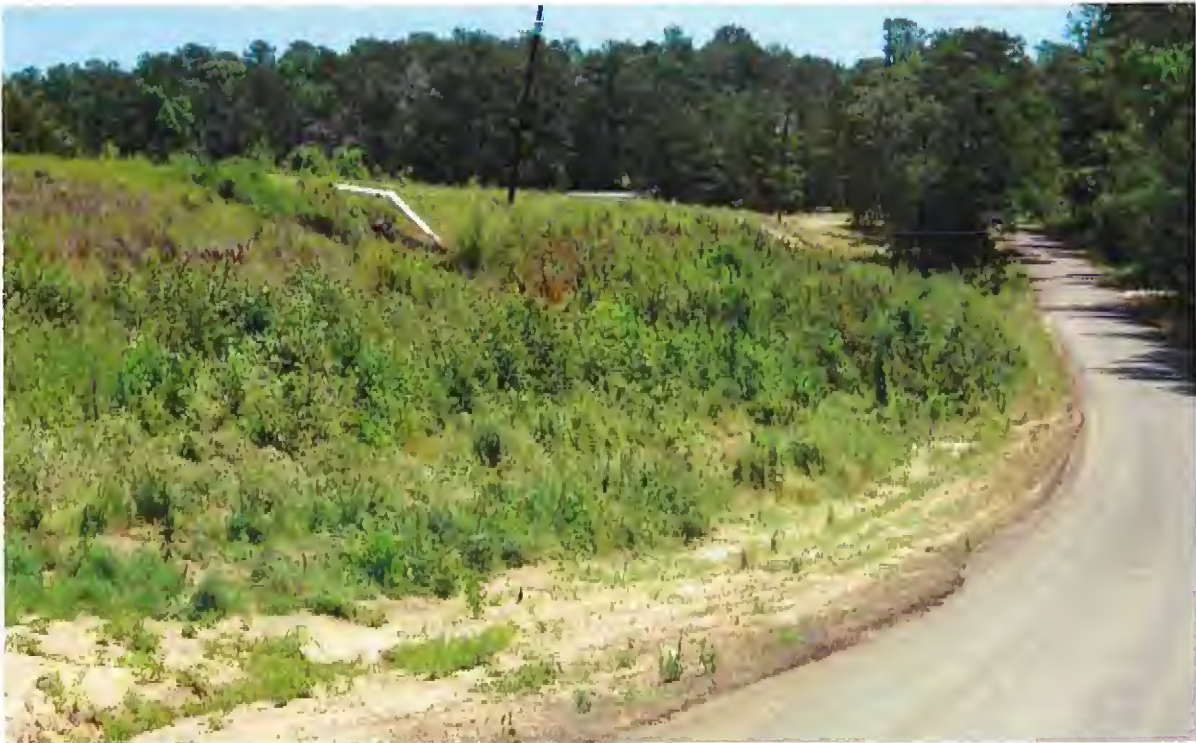
- Small trees were growing back from cut stumps [Photos 7-8], and
- Cut trees that were on the embankment in the March 2010 inspection had been removed.

Photo 7: Overall view of the downstream slope. Note the small trees re-growing from cut stumps. Also, note that the brush piled on the slope during the March 2010 inspection had been removed.

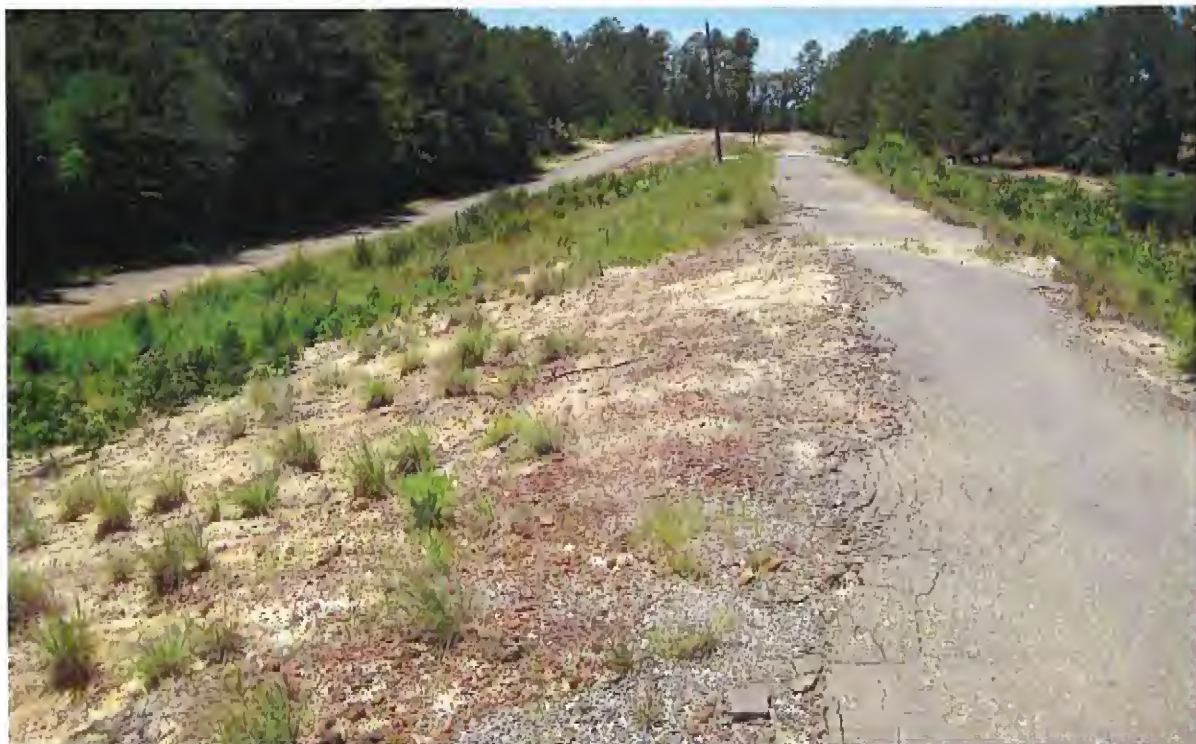
Photo 8: Another view of the dam from the left end of the crest.
